PROJECT NAME: SAMPLE  
PROJECT LOCATION: SOMERSETT, U.S.A.  
ARCHITECT: SAMPLE ARCHITECT

DRAWN BY: J.O.R  
CHECKED: A.D.S.  
DATE: 09-01-09  
SCALE: FULL  
DRAWING NO: 1234A  
SHEET: V1

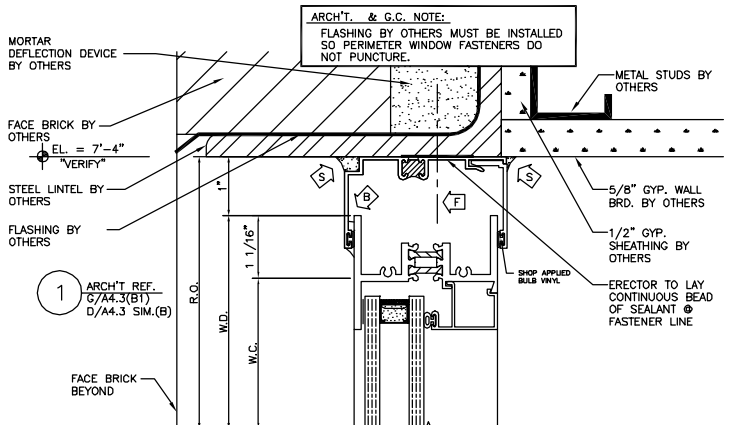
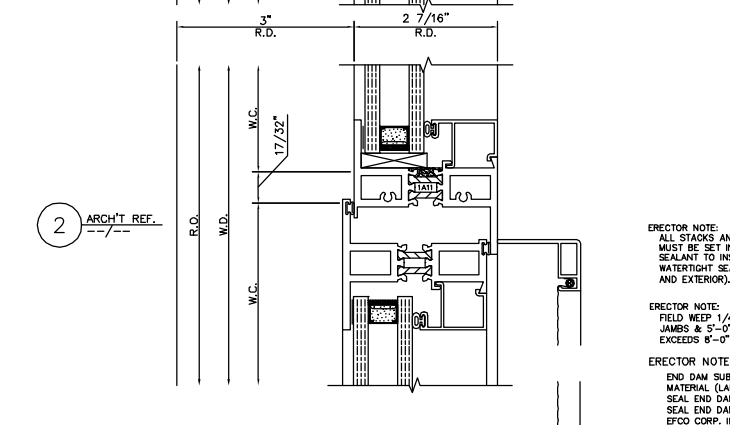
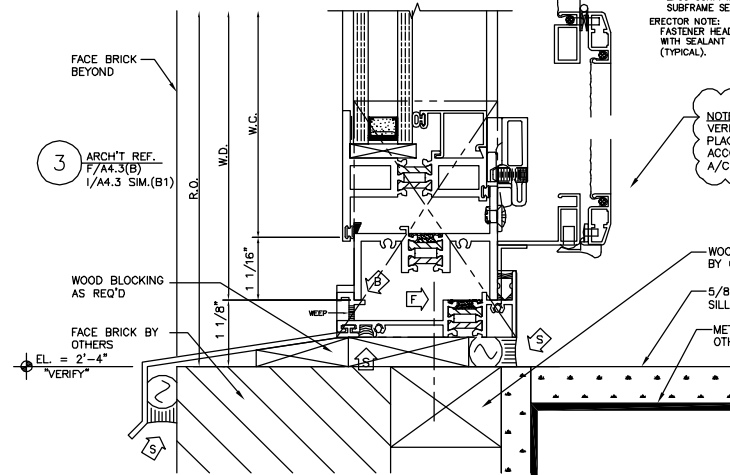
ARCH'T. & G.C. NOTE:  
FLASHING BY OTHERS MUST BE INSTALLED  
SO PERIMETER WINDOW FASTENERS DO  
NOT PUNCTURE.

ERECTOR NOTE:  
ALL STACKS AND SUBILLS  
MUST BE SET IN A BED OF  
SEALANT TO INSURE A  
WATERTIGHT SEAL (INTERIOR  
AND EXTERIOR).

ERECTOR NOTE:  
FIELD WEEP 1/4" DIA. 6" FROM  
JAMES & 5"-0" O.C. IF FRAME  
EXCEEDS 8'-0" WIDE.

ERECTOR NOTE:  
END DAM SUBSILL WITH FLASHING  
MATERIAL (LABOR BY ERECTOR).  
SEAL END DAM TO SUBSILL, THEN  
SEAL END DAM TO CONDITION. PER  
EFOOD CORP. INSTALLATION INSTRUCTIONS  
SUBFRAME SECTION. (TYPICAL)

ERECTOR NOTE:  
FASTENER HEADS AT SILL MUST BE COVERED  
WITH SEALANT TO INSURE A WATERTIGHT SEAL  
(TYPICAL).
